20 March 2012

**RE: HOUSE INSPECTION - 123 Jan Brand Street Fairy vale Bloemfontein**

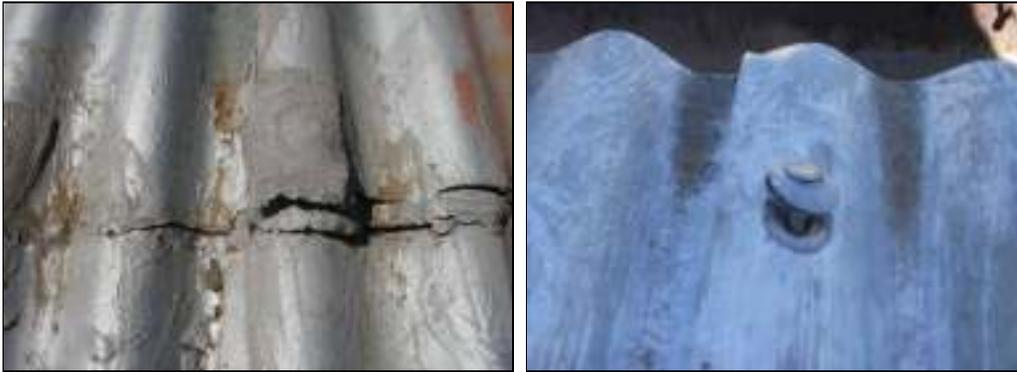
### Roof

The house has a flat roof. The roof is covered with galvanized corrugated sheets. Some of the roof nails appears to be loose and should be fastened to prevent water from entering the roof cavity. The acrylic sealer on the roof nails is weathered and should be re sealed. The flashings at the toilet vent pipe and the chimney on the western side is weathered and should be redone. The concrete roof section has small cracks that cause water to enter the roof. The hairline cracks have been sealed with acrylic sealer that has weathered in time. It is advisable to reseal the entire concrete roof.

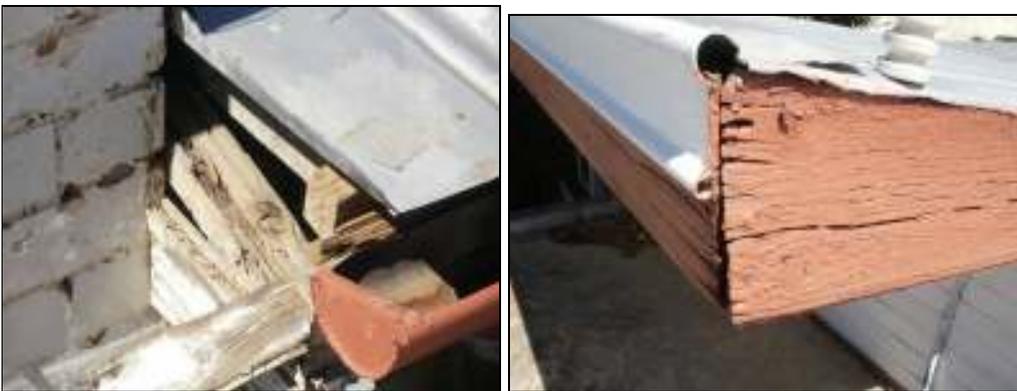
The eaves are generally in a fair condition. However some fascia boards are rotten especially at the kitchen and at the eastern side. Although all the fascia boards have recently been painted there are still signs of weathering. Some of these fascia boards need to be replaced and a few purloins are rotten at the overhangs.

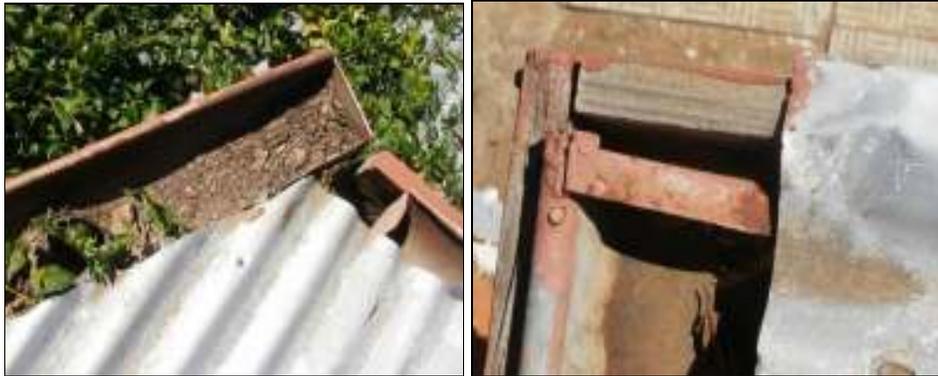
**Gutters and down pipes**

Most of the gutters appear to be rusted. These gutters could either be replaced or repainted and refastened.

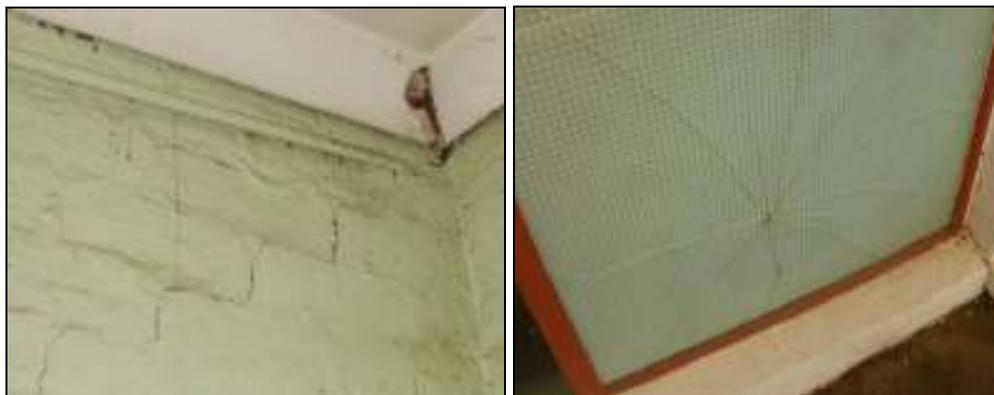
**Garage and outbuildings**

These buildings have quite a few cracks which can be repaired and repainted. There is damp in the southern wall which is the result of water entering in between the fascia board and the roof sheet. This damp can be repaired by sanding down and repainting the wall. The roof has some loose screws which should be refastened and resealed. The gutters appear to be too short which allows water to flow onto the fascia boards and causes rotting of the fascia boards. One window is badly cracked and needs to be replaced.

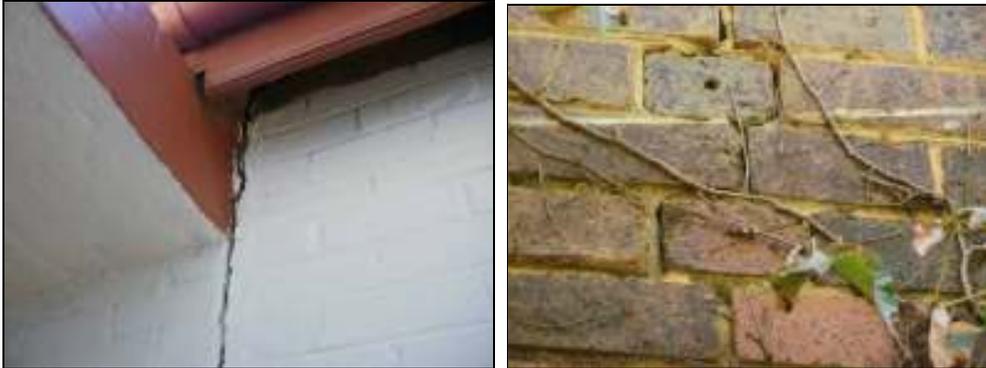
**Main Superstructure (Walls)**

Apart from the minor hairline cracks at the windows that is normal for the area that does not have expansion joints the superstructure of the house is in a fair condition. Big cracks at the front entrance and at the southern wall of the dining room can be seen where it has been build on to the main structure. These cracks should be repaired. An expansion joint should be placed here to allow for movement. A crack is also visible on the western wall which seem stable at the moment.

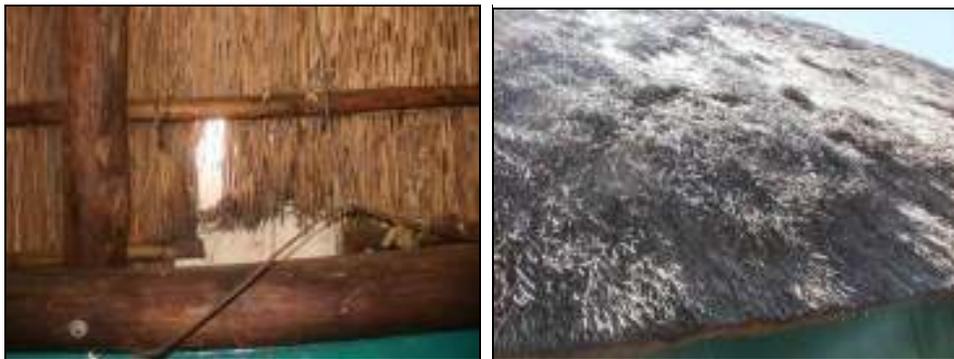
**Braai area**

The braai area has a thatch roof which is in a poor state and is in need of immediate attention.

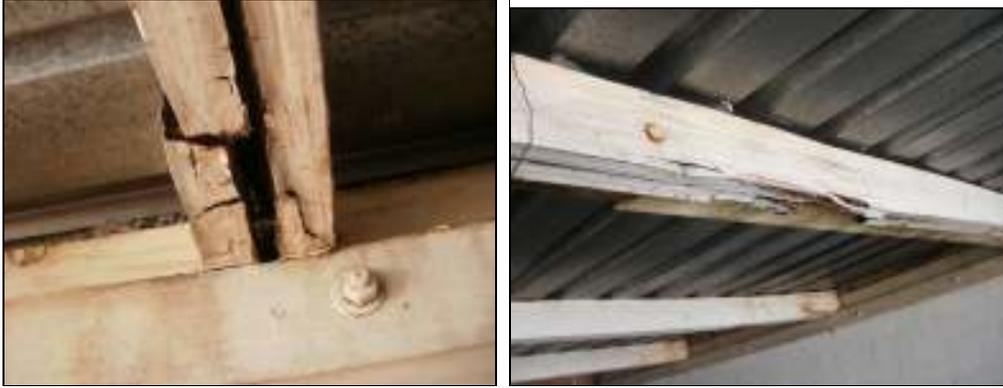
**Carport**

The carport is in a poor state as most of the timber beams are rotten which should be replaced.

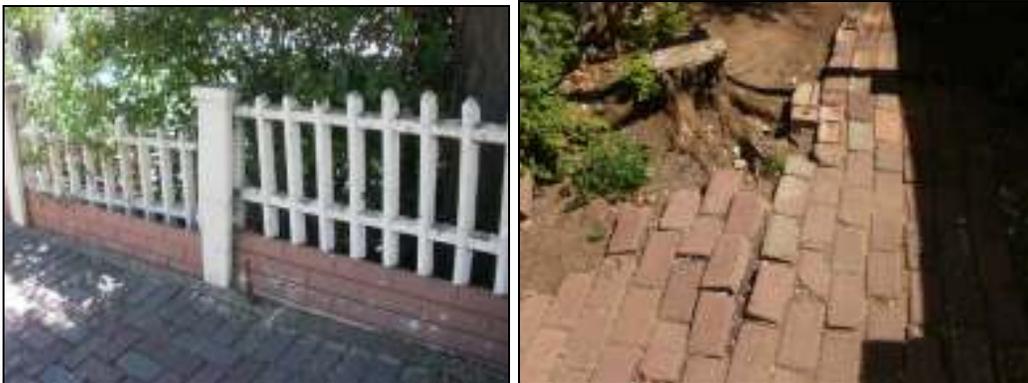
**Paving and boundary walls**

The boundary wall is in a fair condition except for some places where the concrete slabs are either loose or leaning to one side. The paving around the house is overall in good condition apart from a few areas that needs repairs.

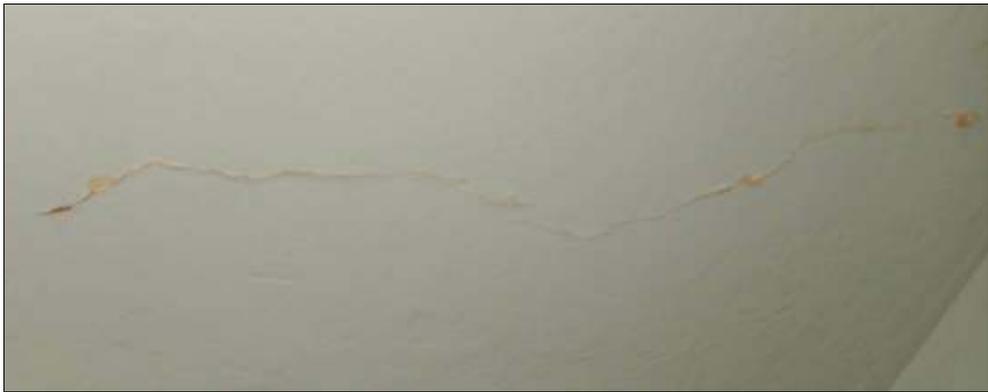
**Foyer and hallway**

There is a crack between the foyer and the dining room wall which needs filling and paint. The ceiling needs some cosmetic attention where the cornice is opening up against the walls. The concrete ceiling in the foyer and hallway shows signs of water damp. This water stain should be sanded and repainted after the roof has been sealed. The sealing and cornice needs minor cosmetic attention at some places. Cracks are present at the hallway and main bedroom doors which can be repaired by filling and painting.

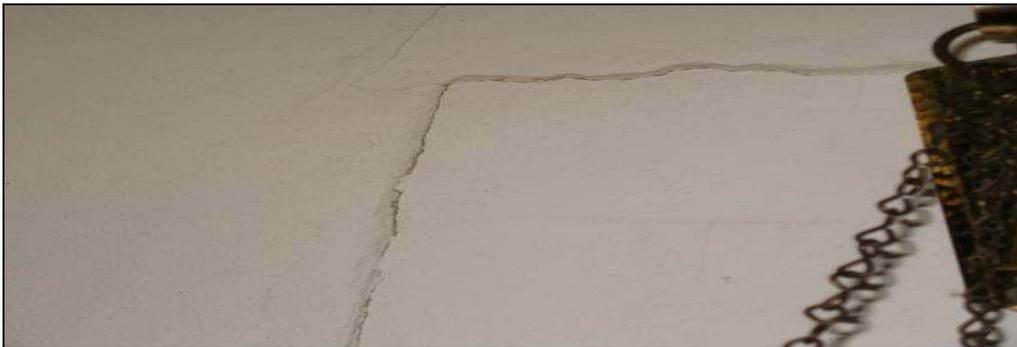
**Dining Room Area**

This area is generally in a fair condition apart from a crack on the ceiling of the entrance to the kitchen. Two cracks can be seen on both the south and northern walls where the build structure meets the existing building. The ceiling is sagging and should be refastened. The polystyrene blocks on the ceiling is loose at some places and should be glued back in place.

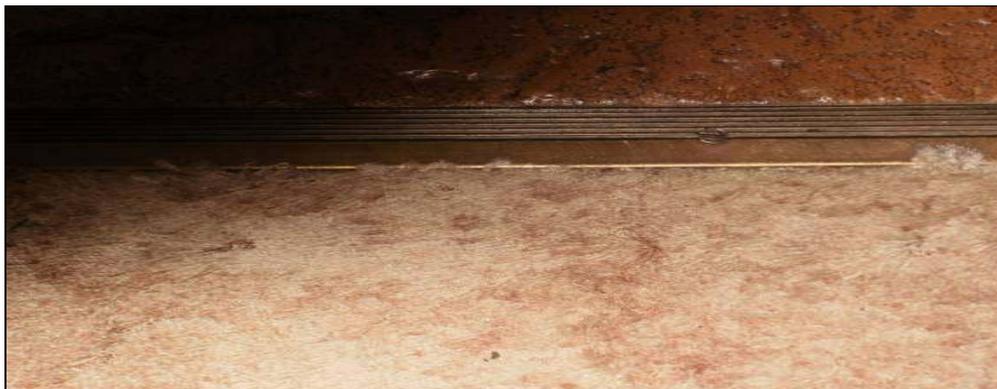
**Lounge area**

The carpet is slightly weathered at the entrance of the foyer. This area is overall in a good condition with minor hairline cracks at the window and sliding door. The wall paper is coming undone at some places and needs to be refastened to the wall.

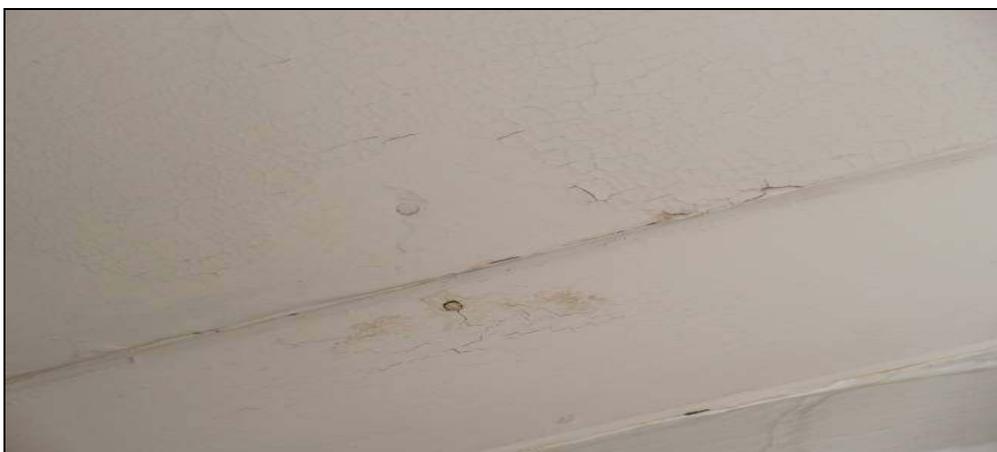
**Living room**

This area seems fine accept for small cracks above the sliding doors. The sliding door on the eastern side needs maintenance for the rollers need to be replaced. The ceiling shows signs of water damp which should be painted and the roof sealed. The ceiling needs minor cosmetic attention at the cornices and where the paint is slightly peeling off. The wooden sliding door is missing a handle which should be replaced.

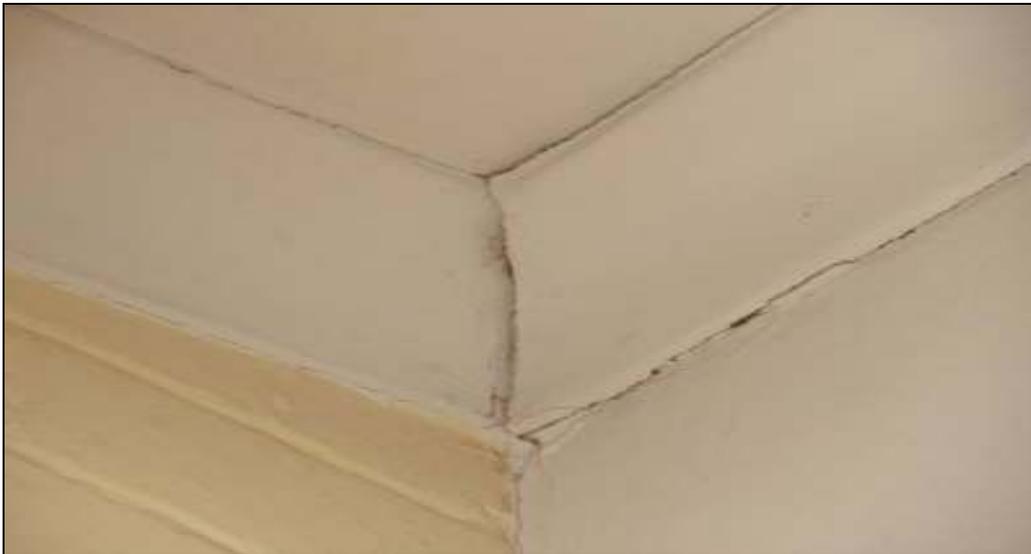
### Bedroom Area

All the bedrooms on the north side are in a generally good condition. All these rooms have minor hairline cracks which should be sealed and repainted. These cracks however seem stable. The ceilings of these rooms all needs minor cosmetic attention at places where the paint is starting to peel off and where the cornices are slightly loosening from the walls. The ceilings should be repainted for it has dark markings, which is the result of the heat of the flat roof. The floors are covered with vinyl tiles with loose carpets on top. These carpets are not fixed under the quarter rounds against the walls.

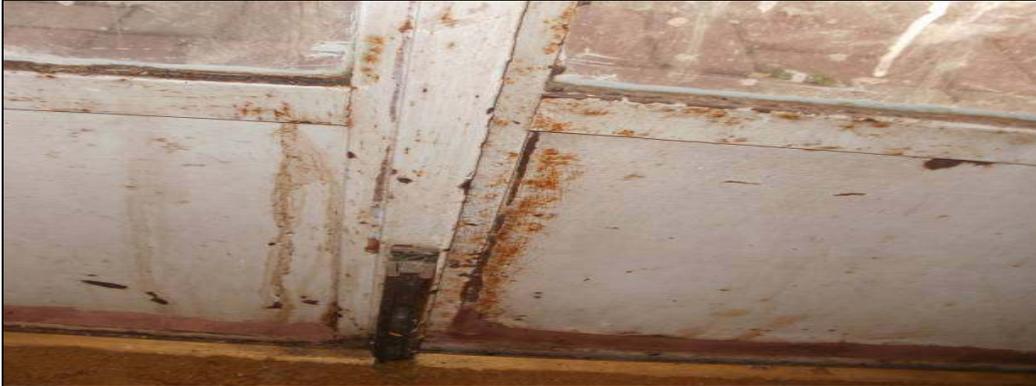
### The main bedroom:

The ceiling and cornices needs cosmetic attention and should be repainted to cover the dark patches caused by the heat from the flat roof. The carpet is slightly weathered. There is a small hairline crack on top of the window corner which needs paint. There are cracks inside the cupboard which needs fixing. The section which was built on appears to be cracking at the joint. Damp is present in the southern wall of the room which is the result of an overflowing and loose

gutter on top of this wall. The gutter should be refastened and the water damp on the wall fixed. The steel door on the north side is rusting and needs to be sanded and painted. Some cupboard handles are loose. The window frames need sanding and paint at some places. The door entering to the en suite bathroom needs paint. This bathroom is in a fair condition except for two cracked tiles against the bath.

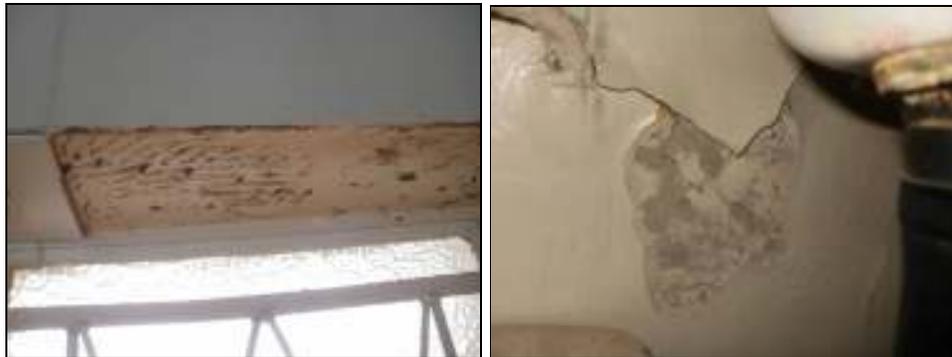
### **Bathroom**

The skirting needs to be sanded and repainted. Some of the tiles are loose and needs to be re grouted. Paint is peeling of underneath the basin cupboard and some tiles are missing. The ceiling needs minor cosmetic attention. Some of the tiles against the bath are cracked. Tiles are missing and loose above the toilet.
